Harbor Marine Surveyors

PRE-PURCHASE INSPECTION SURVEY

M/V Blue Haven

2018 Sabre 42 Hardtop Express

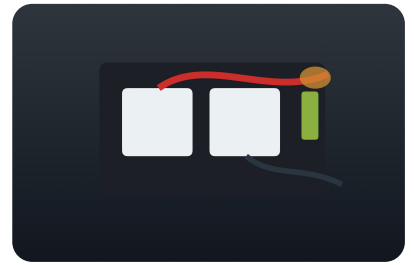
Starboard Battery Bank

SAFETY / IMMEDIATE

Description: The starboard battery positive cable was inadequately supported and exhibited light corrosion at the retaining hardware, increasing the risk of chafe and unintended movement in service.

Cited Standard: ABYC E-11

Supporting Evidence: Verified by direct visual inspection with unsupported cable movement and light corrosion staining at the securing hardware.

Tools / Readings: Infrared Thermometer: 101 F terminal clamp after charging cycle

Recommendation: Renew the affected support hardware, secure the conductor with marine-rated restraint, clean and protect the connection points, and confirm compliant installation before routine operation.

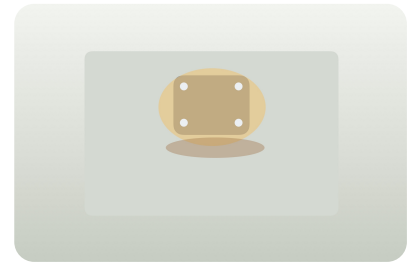
Foredeck / Windlass Base

ESSENTIAL REPAIR

Description: Localized moisture intrusion was indicated at the forward windlass fastener group and adjacent deck core showed elevated readings when compared with surrounding laminate.

Cited Standard: ABYC H-40

Supporting Evidence: Moisture meter response increased materially around the windlass fasteners and minor sealant separation was visible at the bedding margin.

Tools / Readings: Moisture Meter: 22-26% WME localized at fastener circle

Recommendation: Remove the affected hardware, dry and repair the compromised core as required, then re-bed the hardware using accepted marine practice before extended service.

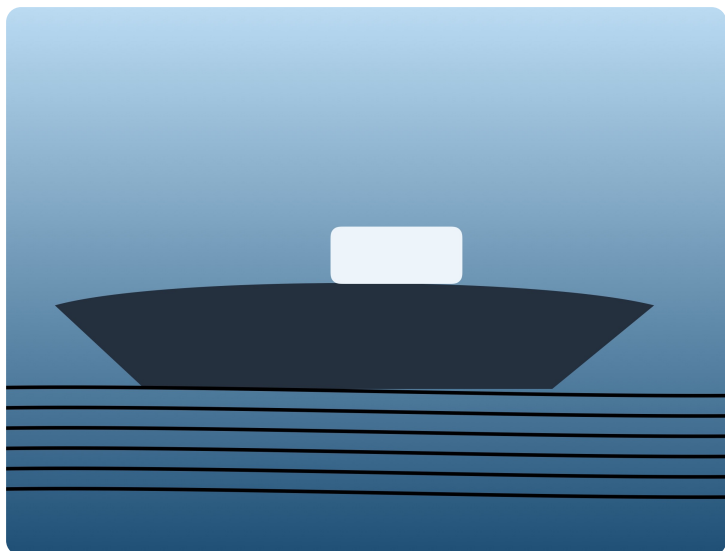
| ITEM | STATUS | OBSERVATION |
|---|---|---|
| Hull Shell and Topsides | CHECKED | <p>Percussion sounding and moisture sampling of accessible hull shell areas disclosed fair-to-good laminate integrity with no widespread delamination detected.</p> <p>1 photo</p> |

Hull Shell and Topsides: Starboard sheer and topsides overview at the launch slip.

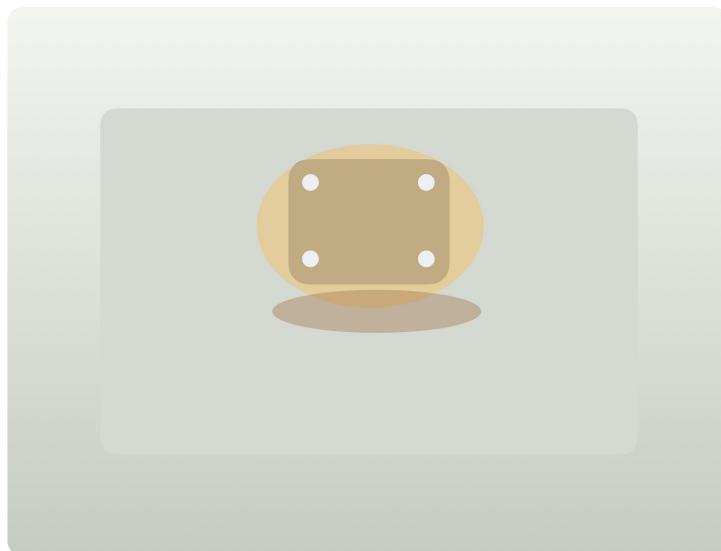
| ITEM | STATUS | OBSERVATION |
|---|---|---|
| Foredeck and Mooring Hardware | FLAGGED | <p>Localized elevated moisture response and failed bedding compound were noted at the windlass foundation and starboard forward cleat fasteners.</p> <ul style="list-style-type: none">• Essential Repair: Localized moisture intrusion was indicated at the forward windlass fastener group and adjacent deck core showed elevated readings when compared with surrounding laminate. <p>Recommendation: Remove the affected hardware, dry and repair the compromised core as required, then re-bed the hardware using accepted marine practice before extended service.</p> <p>1 finding • 1 photo</p> |

Foredeck / Windlass Base: Moisture indication around windlass fastener bedding.

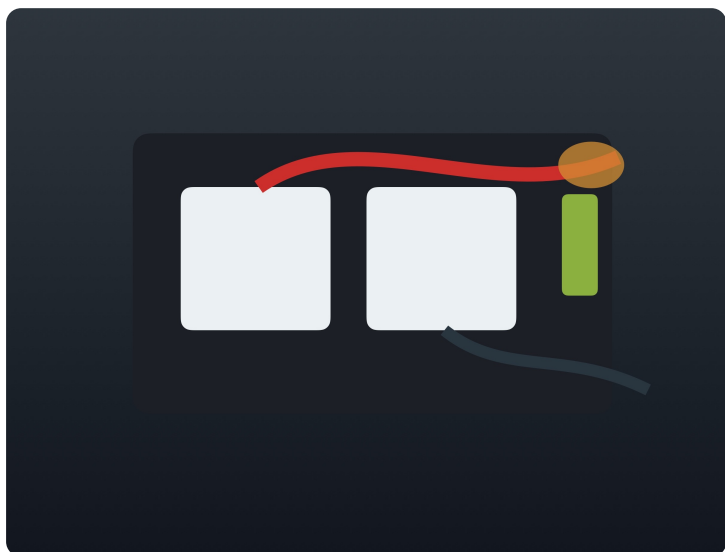
| ITEM | STATUS | OBSERVATION |
|--|---|---|
| Battery Installation | FLAGGED | <p>House and engine battery banks were generally serviceable, but support and conductor routing required correction at the starboard side.</p> <ul style="list-style-type: none">• Safety / Immediate: The starboard battery positive cable was inadequately supported and exhibited light corrosion at the retaining hardware, increasing the risk of chafe and unintended movement in service. <p>Recommendation: Renew the affected support hardware, secure the conductor with marine-rated restraint, clean and protect the connection points, and confirm compliant installation before routine operation.</p> <p>1 finding • 1 photo</p> |

Starboard Battery Bank: Unsupported positive cable and corrosion at battery hold-down area.

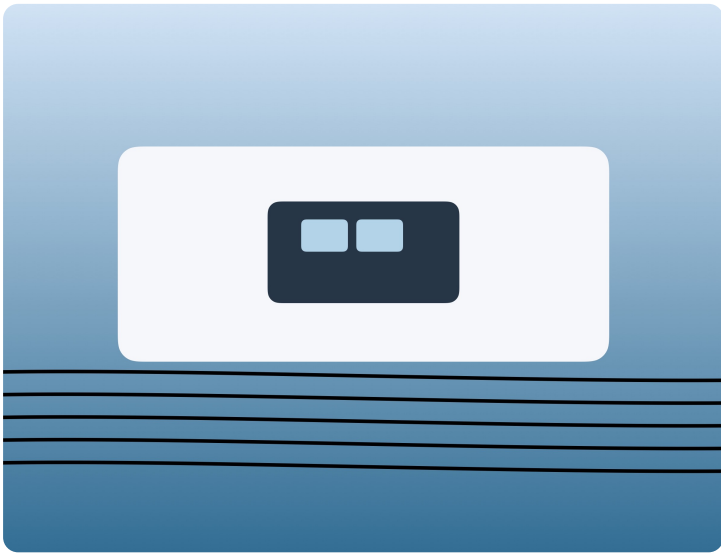
General Reference Photo: Aft quarter and swim platform overview.
